**DEPARTMENT OF TRANSPORTATION**

Contract #: 04-0120F4Cty: SF/ALA Rte: 80 PM: 13.2/13.9File #: 78.28**WELDING INSPECTION REPORT****Resident Engineer:** Casey, William**Address:** 333 Burma Road**City:** Oakland, CA 94607**Report No:** WIR-030045**Date Inspected:** 19-Sep-2013**Project Name:** SAS Superstructure**OSM Arrival Time:** 1500**Prime Contractor:** American Bridge/Fluor Enterprises, a JV**OSM Departure Time:** 2330**Contractor:** Steward Machine Co.**Location:** Birmingham, AL**CWI Name:** Fred Hudson / Jimmy Brewer**CWI Present:** Yes No**Inspected CWI report:** Yes No N/A**Rod Oven in Use:** Yes No N/A**Electrode to specification:** Yes No N/A**Weld Procedures Followed:** Yes No N/A**Qualified Welders:** Yes No N/A**Verified Joint Fit-up:** Yes No N/A**Approved Drawings:** Yes No N/A**Approved WPS:** Yes No N/A**Delayed / Cancelled:** Yes No N/A**Bridge No:** 34-0006**Component:** E2 Shear Key Anchorages**Summary of Items Observed:**

Quality Assurance Inspector (QAI) Andrew Webster was present on the date and times noted above in order to observe the fabrication and Quality Control (QC) functions performed by Steward Machine Company for the E2 Shear Key Anchorages for

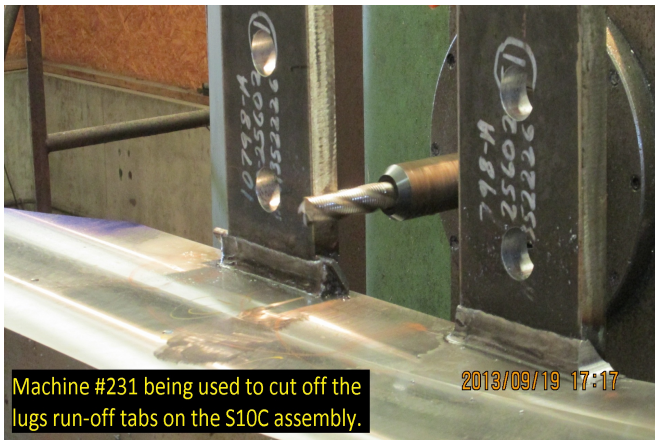
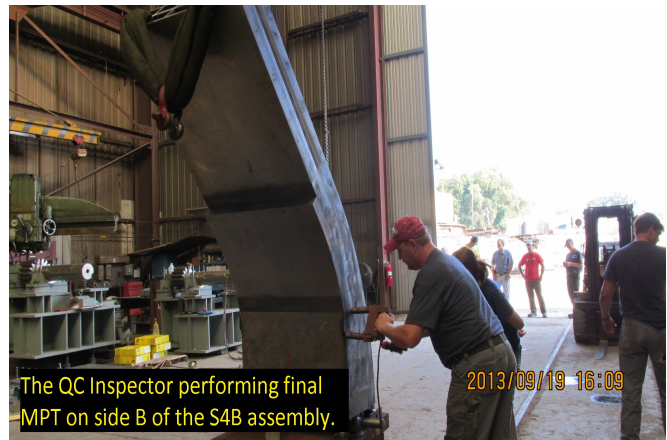
This QAI noted the above mentioned assembly was held in position while the e4 plate was put into place as a test fit to verify it would work before blasting. After the e4 plate was removed this QAI witnessed the QC Inspector MPT the S4B assembly on sides A and B as well as the west end. During their inspection two indications were marked for repair on side A.

This QAI was informed that the two repairs for the S4B assembly were finished and that the assembly was ready for QA final MPT. This QAI performed the required MPT verification on side A and B as well as the west end.

The above mentioned assembly was moved from machine #231 to the floor at which time this QAI witnessed the QC Inspector MPT the lug welds. After the QC Inspector was done with his MPT inspection this QAI performed the required MPT verification on the four lug weld as well as a final MPT on side A and side B of the S10C assembly.

The Non Destructive Testing (NDT) listed above were observed performed and accepted by the QC Inspectors prior to the QA Inspector performing the tests. The QC Inspectors performed 100% NDT with the QA Inspector performing over 10% NDT.
